## Understanding the Gold King Mine Spill

*Authors: Karletta Chief, Janick F. Artiola, Sarah T. Wilkinson, Paloma Beamer, and Raina M. Maier*

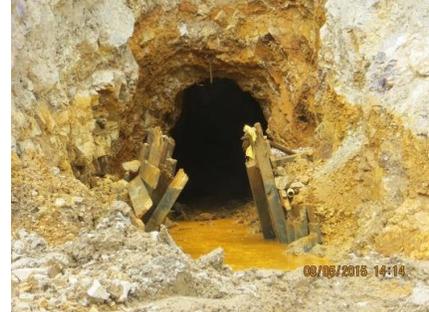
**Figure 1: The mining tunnel from which the spill occurred (US EPA via Flickr, 2015).**

On Wednesday August 5, 2015, during a United States Environmental Protection Agency (US EPA) mine site investigation of the abandoned Gold King Mine near Silverton, Colorado, heavy equipment disturbed loose material around a soil “plug” at the mine entrance. Acid mine drainage had built up behind the plug, which unexpectedly gave way due to water pressure in the tunnel, and a torrent of water gushed out (Figure 1). This accident resulted in the release of approximately 3 million gallons of acid mine drainage into Cement Creek, a tributary of the Animas River, which in turn flows into the San Juan River and ultimately into the Colorado River. The water contained a number of heavy metals such as lead and arsenic.

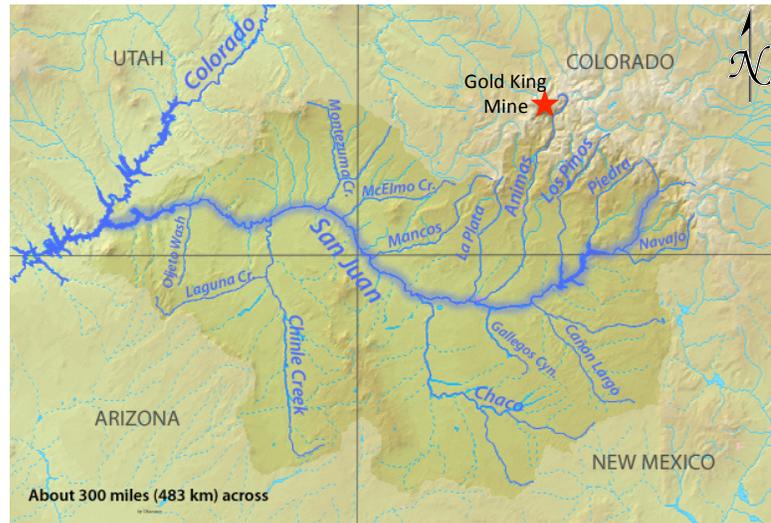
Figure 2: The San Juan River portion of the Colorado River Basin. The red star indicates the site of Gold King Mine spill. (Adapted from "Sanjuanrivermap" by Shannon via Wikimedia Commons.)

The Gold King Mine spill occurred in the Upper Colorado River Basin (Figure 2 shows the San Juan River portion closest to the spill). This watershed includes six US states (Colorado, Utah, New Mexico, Arizona, Nevada, and California), and 12 Native American tribes live along the tributaries. The Southern Ute Indian Tribe, the Navajo Nation, and the Ute Mountain Ute Indian Tribe are tribes nearest to the spill. Community meetings have been held to provide updates and minimize acute exposure, but many people still have questions.

The Gold King Mine spill occurred in the Upper Colorado River Basin (see Figure 2, above). The approximately 9.3 acre-feet of acid mine drainage released in the spill became diluted very quickly in the flow of the affected waterways. Estimated dilutions of the spill at different locations can be calculated using data from the United States Geological Survey (USGS) National Water Information System (USGS, 2015). The following sections trace the flow of the water in more detail and describe the estimated dilution of the acid mine drainage.

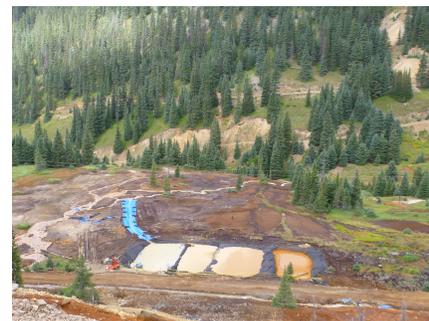
Figure 3: Settling ponds built near Gold King mine allow acid mine drainage to pool, where contaminants can settle to the bottom and acidity can be treated. (US EPA via Flickr, 2015).

Within two days after the spill occurred, the US EPA built settling ponds (temporary solution) to divert additional acid mine drainage flow away from Cement Creek, and treated the water to neutralize the acid and remove solids and metals from the water (Figure 3; US EPAe, 2015). These ponds remain in use as of October 2015. The US EPA has announced it will install a portable treatment system to handle the ongoing discharge (approximately 550 gallons per minute) from Gold King throughout the winter of 2015-2016, as freezing temperatures will make it unsafe to continue to treat it using settling ponds. The treatment system will lower the acidity and remove solids and metals from the acid mine drainage before it reaches Cement Creek (US EPAd, 2015). To date, US EPA has not made a decision about whether to build a long-term wastewater treatment plant at the site (US EPAa, 2015).

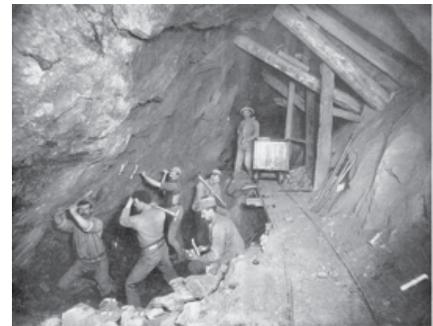
Figure 4: Gold King Mine circa 1899 (Church et al., 2007).

The Gold King Mine was discovered in 1887 and operated until 1922 (Figure 4). There are approximately 23,000 abandoned mines in Colorado where the Gold King Mine is located (Colorado Department of Natural Resources, 2014). As a result, it is only one of many abandoned gold and silver mines located near Silverton, Colorado within the Upper Animas watershed, reflecting more than 120 years of gold, silver, lead, zinc, and copper mining, spanning from 1871 to 1991. During these years an estimated 8.6 million tons of mill tailings were discharged into the waterways (Church et al., 2007). Studies have shown that both natural weathering and continuous acid mine drainage generated from the abandoned mines have impacted water quality in the area, where the water is often acidic and contaminated with heavy metals (Church et al., 2007; US EPAC, 2015).
